Roy Wilcox Airport

JULY 6, 2011

ANNUAL INSPECTION REPORT

ROY WILCOX AIRPORT
CHATOM, ALABAMA

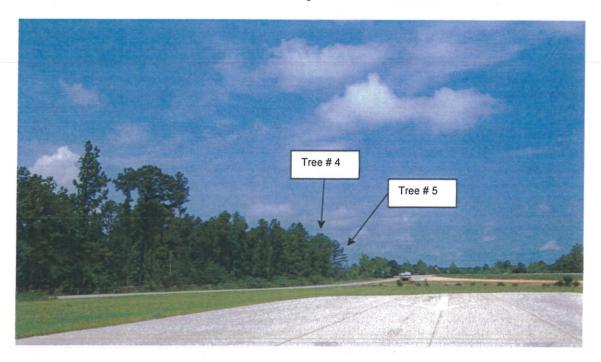
Photo #1 - Runway 12 Obstructions

- Runway 12 Trees identified as Tree # 4, Tree # 5 and Tree # 6 obstruct the ALDOT 20:1 approach/departure path (See Photo # 1, # 2 and Appendix 2).
- Runway 30 No obstructions (See Photo # 3 and Appendix 3).

Several safety issues have been resolved; however obstructions remain in runway12's approach path and must be removed for an operating license to be issued. Once this has been accomplished, you may contact the Aeronautics Bureau to schedule a reinspection.

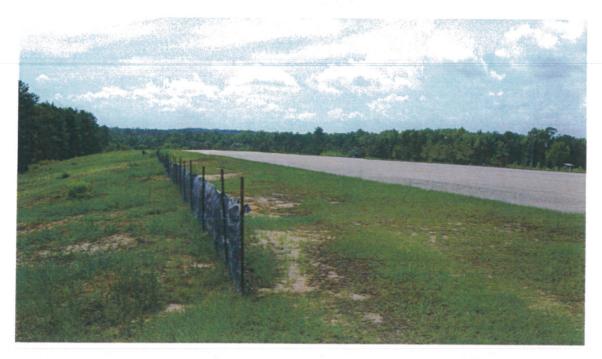
The southeastern side of the runway's primary surface has recently been cleared and a silt fence has been installed to prevent erosion. Vegetation appears to have grown sufficiently to allow removal of the fence from the primary surface (See Photo # 4).

- Remove silt fence.
- 3. Runway Safety Area Administrative Code 450-9-1-.12(3)

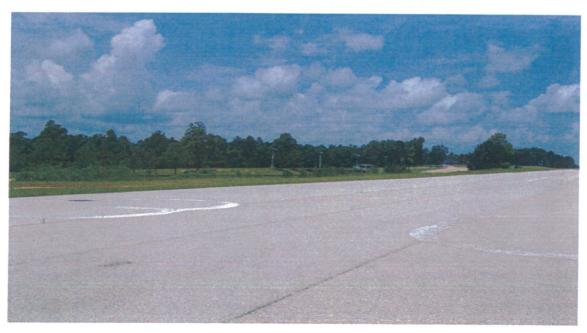
• The airport markings are nonstandard, faded and in poor condition (See Photo # 5).

Markings should be replaced in accordance with FAA AC 150/5340-1K.

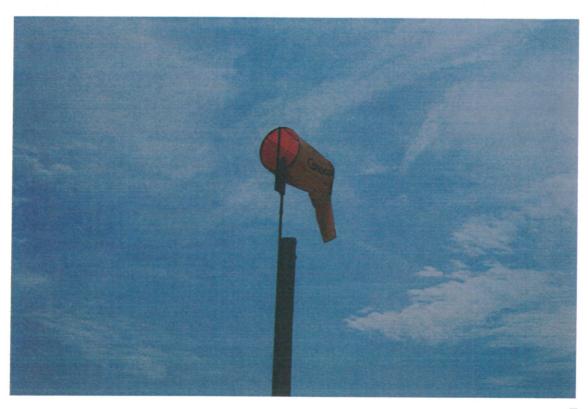
• The wind direction indicator (wind cone) is operational and in good condition (See Photo # 6).

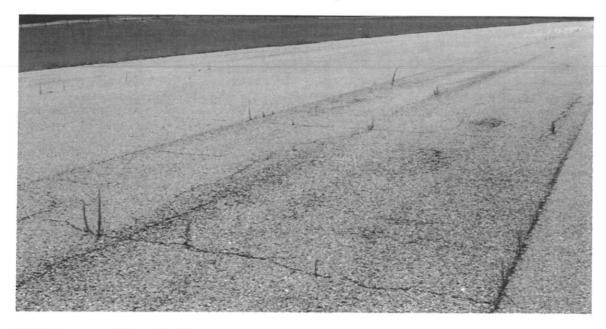
The airport pavement surfaces are in good condition; however there is moderate raveling and some paving joint cracks with vegetation evident (See Photo # 7).

Eradicate the vegetation, clean and seal the cracks and apply a surface treatment or thin overlay.

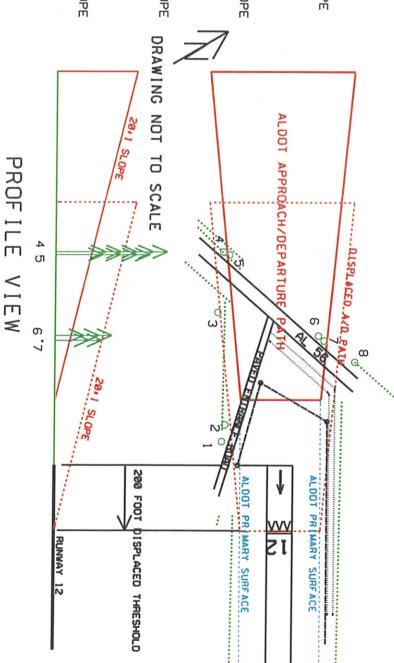
APPENDIX 2

- 4. TREE 69' ABOVE RUNWAY END 867' FROM DISPLACED THRESHOLD 181' RIGHT OF CENTERLINE 12:1 OBSTRUCTION CLEARANCE SLOPE FROM DISPLACE THRESHOLD
- 5. TREE 58.5' ABOVE RUNWAY END 855' FROM DISPLACED THRESHOLD 162' RIGHT OF CENTERLINE 14:1 OBSTRUCTION CLEARANCE SLOPE FROM DISPLACE THRESHOLD
- 6. TREE 35' ABOVE RUNWAY END
 606' FROM DISPLACED THRESHOLD
 117' LEFT OF CENTERLINE
 17:1 OBSTRUCTION CLEARANCE SLOPE
 FROM DISPLACE THRESHOLD
- TREE 29' ABOVE RUNWAY END
 594' FROM DISPLACED THRESHOLD
 135' LEFT OF CENTERLINE
 20:1 OBSTRUCTION CLEARANCE SLOPE
 FROM DISPLACE THRESHOLD
- * NOT AN ALDOT OBSTRUCTION
